**"SOIL-STRUCTURE INTERACTION IN SIDI RACHED MASONRY BRIDGE "**

# Soil–Structure Interaction in Sidi Rached Masonry Bridge

Marco Petrangeli, Prof.; Paola Rita Marcantonio, Arch.; UNI–INGEO, Pescara, Italy; Paolo Tortolini, Civil Eng.; INTEGRA S.r.l., Rome, Italy. Contact: marco@integer.it

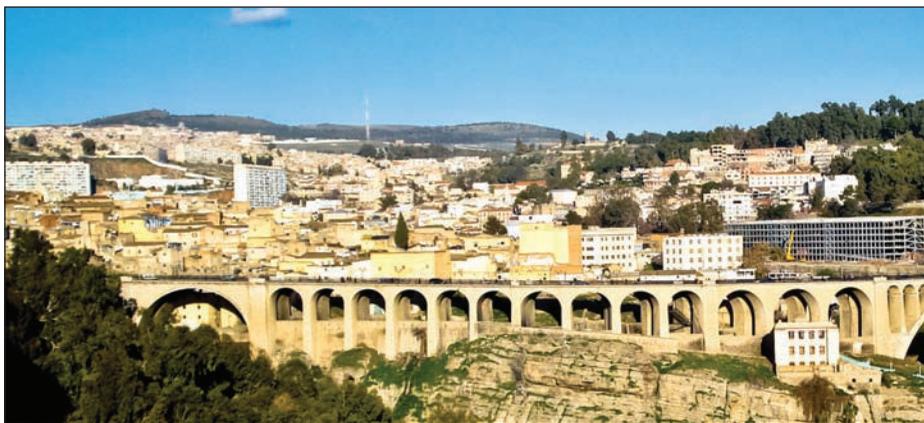
Fig. 1: The Sidi Rached Bridge seen from upstream (right bank on the right)

The Sidi Rached Bridge is a stone masonry arch bridge made of 27 arcades. The typical arcade has a clear span of roughly 9 m, four have 16 m spans, one has 30 m span and the main arcade crossing the Rhumel has a clear span of 68 m standing at 102 m above the bottom of the canyon. The bridge does not have solid arcades but is made of two parallel ones, 4 m wide, 4 m apart for a total platform width of 12 m. Each support is therefore made of two tapered piers with a rectangular section measuring  $4 \times 2$  m at the arc sets. Pier height varies from 10 to 20 m approximately. The bridge deck between the two parallel arches is supported by reinforced concrete transverse beams, spaced at 2 m at the centres (see Fig. 1).

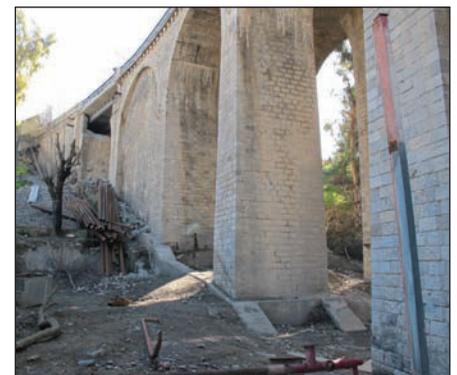
Fig. 3: Existing reinforced concrete beams connecting the foundations of the piers

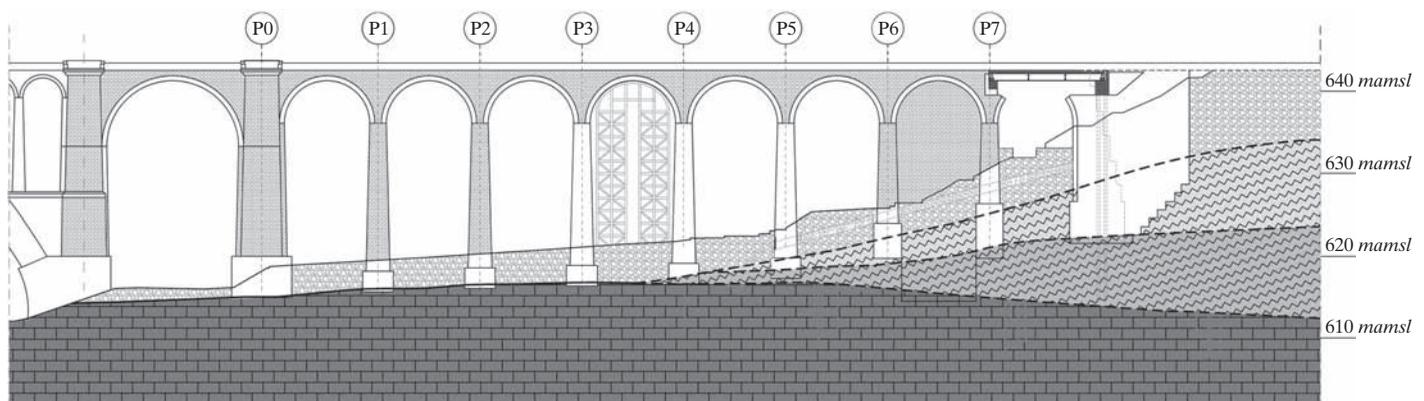
Fig. 2: Geological section of the right side of the Sidi Rached bridge

The Rhumel canyon cuts across the limestone formation that is part of the “Néritique Constantinois” geological domain (Upper Cretaceous).<sup>3</sup> This formation consists of grey to whitish micritic limestone, widely exposed in layers of various thicknesses along the steep banks of the canyon. From a geostructural point of view, the limestone formation forms the flank of a monocline fold that plunges southeast towards the right bank of the valley, with a gentle dip of 5°.

A pelitic formation, discordant and probably overthrust, lies above the limestone layers on the upper part of the right bank, from the edge of the canyon up to the plateau of Mansourah. The pelitic formation is composed of argillites, shales, marls, and often laminated schist. The superficial portion of this formation has been affected by deep weathering and the material has been transformed to a clay plastic soil. The abutment and the first three piers rest on the pelitic formation while the other piers on the limestone layers (see Fig. 2). From a hydrogeological point of view, pelitic formation is made up of fine-grained materials with medium to low permeability. Piezometric monitoring and on-site tests have shown that the underlying limestone layers are generally less permeable than the marls (due to the low fracturation) and

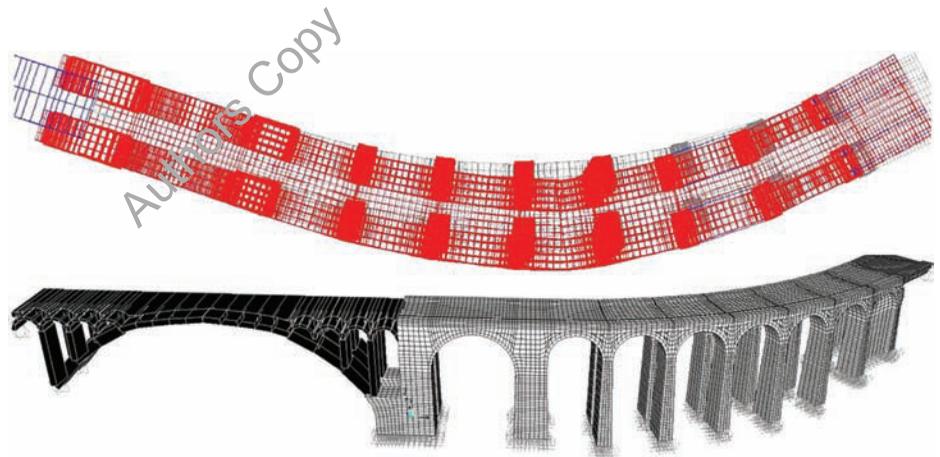
Fig. 5: The finite element model of the Bridge: (bottom) the undeformed mesh; (top) the bridge deformation in plan (amplified by factor of 20)

A three-dimensional (3D) finite element model of the bridge was set up.<sup>4,5</sup> In order to keep the size within acceptable limit, only the arcades on the right bank and the main arcade over the Rhumel were remodelled (see

Fig. 5). The effect of the rest of the bridge (the other 18 arcades on the left bank) was accounted for with boundary (spring) elements. The first seven arcades on the right bank were modelled with brick elements, and the main arcade with beam elements. Given the urgency to understand the mechanics of the damage, a linear elastic constitutive behaviour was applied associated to an iterative element elimination procedure in order to explain the crack development and splitting failure in the masonry elements. A threshold value of 0,1 MPa in tension and 8 MPa in compression was assumed based on literature. With only three iterations the kinematics of the damage mechanism was immediately clear. The approach spans are in a curve, precisely quite a narrow curve (105 m radius). When a push was applied from the abutment, the bridge buckled and swayed outwards. Very wide flexural cracks formed at the pier bases (see Fig. 6). All this was confirmed by the topographic readings; the outward sway of the deck is currently 200 mm circa. Crack openings up to 20 mm at the pier base are consistent with a rigid body kinematics. At the centre of the curve, a plastic hinge developed in the deck with crushing of the inside (downstream) arch. The likely failure scenarios had to be identified so as to carefully evaluate the possibility of keeping the bridge open for pedestrian and light vehicles during the repair works. Although very large, the sway of the deck could not cause any collapse by triggering P-Delta (P-D) effects. Also the crushed arch between Piers 4 and 5, although severely damaged, was held in place by erecting provisional supports (scaffoldings). The numerical simulations clearly identified the brittle failure of the piers as the most critical scenario. Rotations at the pier bases are so high that the compression zones of these sections are very thin and subjected to very high stress, close to stone crush-

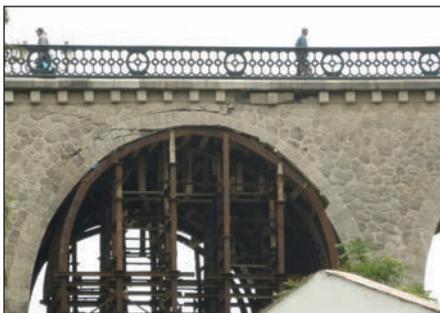
In 2008 the bridge started to develop very wide cracks at the pier bases. The damage extended to the fourth arcade

followed by crushing and spalling of the stone masonry of one arch (see Fig. 4). However the bridge could not be closed to traffic because the city was dependent on this bridge to get across the Rhumel canyon that cuts through its centre.

Fig. 4: Crushing of the arch between Pier 4 and 5

Only then, the collapsed arch between Piers 4 and 5 can be demolished and reconstructed. The interesting and critical aspect of this phase of the work is that, based on the numerical analyses, the bridge deck is still carrying a compression force of 900 t. This force did not decrease substantially upon the removal of the buffer deck between the abutment and Pier 1 because the shear walls built between Piers 1 and 2 prevented the structure from being set back. Demolishing the arcade between Piers 4 and 5 will release the axial compression in the deck and the bridge will set back and partially recover from the swayed and tilted position.

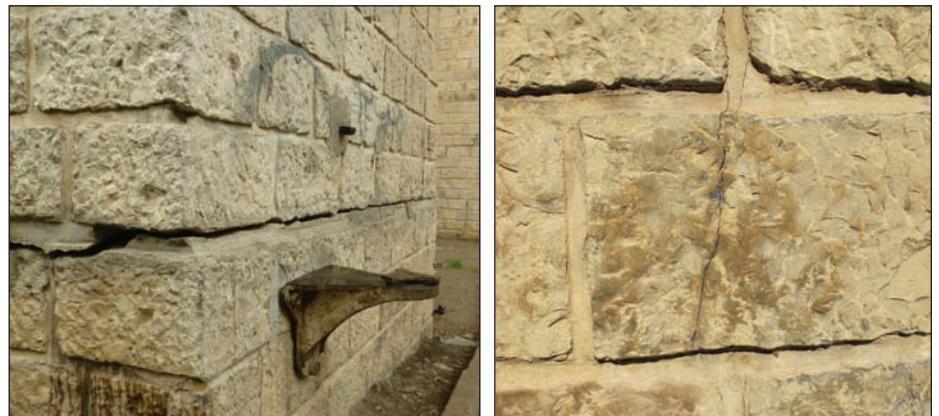
ing, due to the bridge self-weight. The numerical predictions were confirmed in the following months by the splitting cracks that developed in the stone-facings of four piers, where the kinematics of the bridge inflicted the largest rotations at the base sections.

Fig. 6: Cracks at the pier bases caused by the section rotation: (left) mode-I opening on the tensile side; (right) splitting cracks on the compression zone

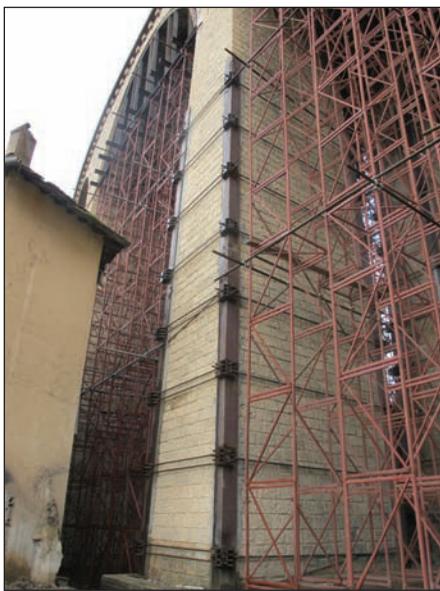
Fig. 7: Emergency propping and pier jacking with steel profiles and external posttensioning

Unfortunately, during fall and winter from 2011 to 2012 the slope sliding peaked again requiring other two arcades to be propped and the most damaged piers had to be reinforced with steel profiles and transverse prestressing so as to prevent their collapse (see Fig. 7).
