Bridge Repair by External Prestress: The Gibe Crossing in Ethiopia

Bridge repair by external prestress: the Gibe crossing in Ethiopia

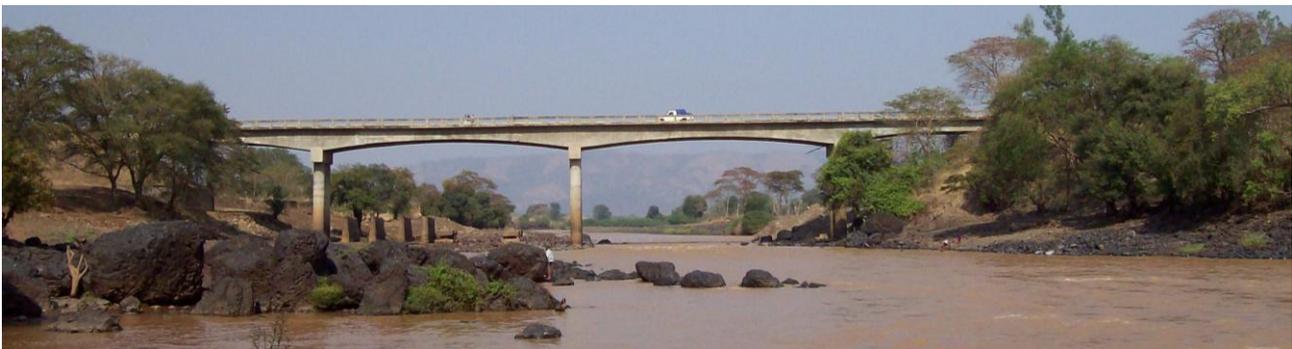
provided an optimal configuration for the cables to be deviated using steel saddles fixed to the concrete structure. Six cables with 12 (06”) strands could be easily spun under the deck, two on each side of the internal beams and one each on the inner side of the lateral beams. The cables are continuous over the whole length of the deck (120m circa) and anchored on the deck slab near the abutments. Cables are deviated using steel saddles and steel pipes directly glued onto the existing concrete sections. Only in few cases (mainly at the anchorages), additional cast in situ concrete blocks were required to allow for a safe transmission of the cable forces to the existing concrete sections.

Special care has been taken in the correct positioning of the deviation elements. Previous experiences suggested to check their correct positioning using a nylon rope before the saddles were glued and the strands were spun. Forces arising from strands jammed into the deviators can be as high as the tensioning force and therefore much higher than the local resistance of the concrete section. This was certainly the case for the Gibe bridge diaphragms that are insufficiently reinforced and therefore could only take the upward design deviation forces and would not bear any tangential ones. The 6 cables tensioned to 1000 MPa apply a total compression force of 1000 ton. The vertical component at the deviation points varies between 20 to 30 ton (upwards) for the 4 intermediate diaphragm along each span and from 70 to 110 ton (down-wards) at piers and abutment.

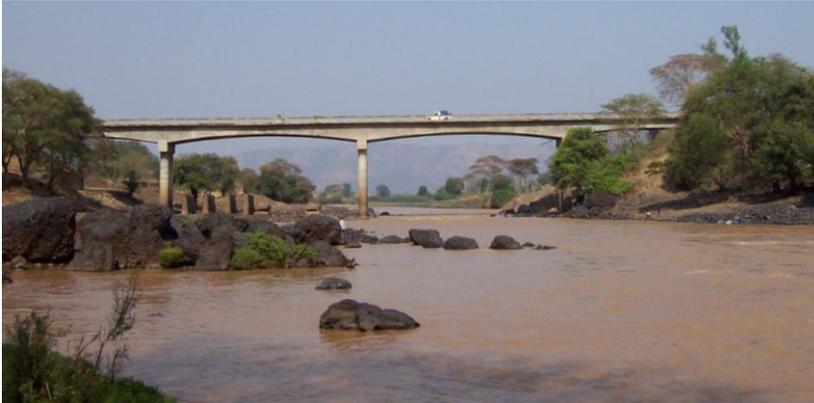
Fig. 1: The concrete bridge over the Gibe river

In the late '70 the crossing was displaced few hundred metres upstream on a more direct alignment that required the construction of a new concrete bridge (Fig.1) made of 4 spans for a total length of

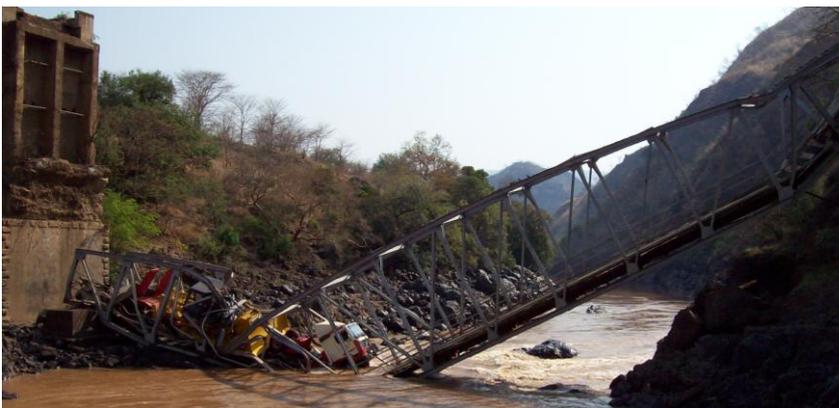
Fig. 2: The collapse of the old truss girder

Recently, due to increased deck deterioration, load restrictions were enforced diverting lorries and other heavy freight to the downstream truss girder. Unfortunately, this structure collapsed in November 2006 (Fig. 2) when a dozer carried by a low loader exceeding the maximum clearance

crashed into the girder upper bracing causing the whole structure to collapse. The traffic had to be diverted back onto the concrete girder with the same load restriction and a reduced carriageway width. The heavier freight had to be rerouted through Nekempt increasing the trip by 150 km along smaller and un-paved roads with severe damage to the country economy.

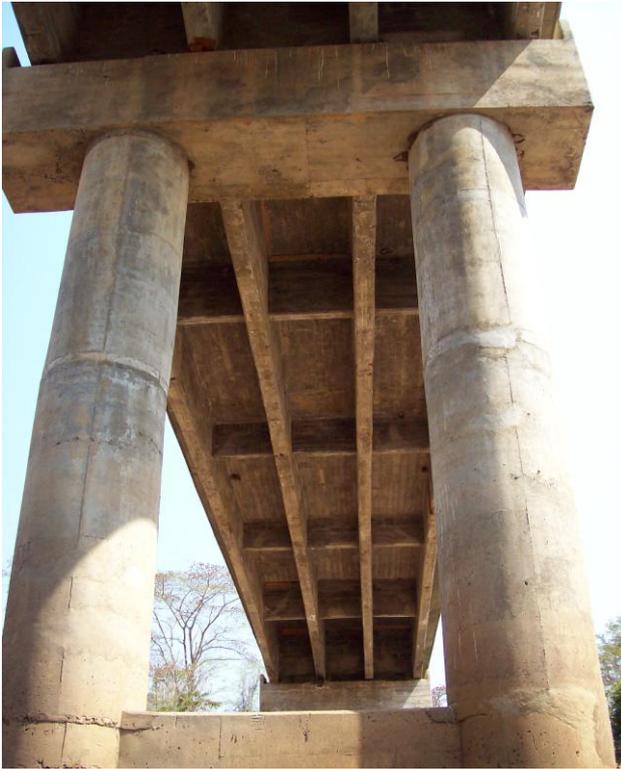
Fig. 3: The Gibe River Bridge

The bridge consists of a continuous reinforced concrete deck, 120.5 metre in length, with 4 spans, 35 m the central ones and 25.25 the lateral ones. The deck cross section is made of an 18cm thick slab and 4 rectangular beams, 40cm thick and with a variable depth between 3.15m over the pier to 1.7m at midspan. The beams are also connected by 18cm thick diaphragms, 4 intermediate ones

each span plus one at each pier. Total deck width is 9.6m, with 8m carriageway and a pedestrian kerb on each side. The 3 piers, all with direct foundations on plinths, are made of 2 circular columns, 5 m apart, connected by a pier cap and a lower diaphragm.

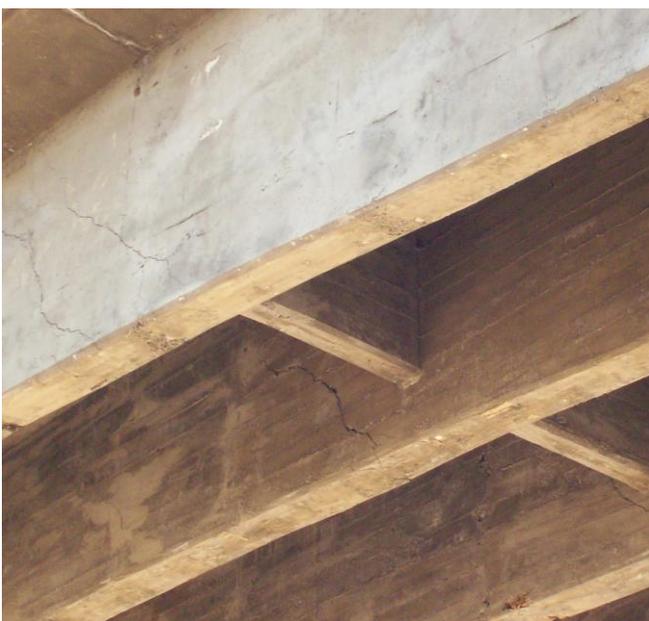
Fig. 4 - Shear cracks in the deck beams

From a simple visual inspection of the bridge it was clear the major damages were the very wide shear cracks (Fig. 4) at both side of the central pier (Pier 2). As said before, the bomb blast severed the deck at 5m from the lateral pier Jima side leaving the deck cantilevering out 25m from the

central pier. This configuration, under dead load only, is by far the most severe the bridge could have possibly undergone during its whole history. With a deck self-weight of 14 ton/m the cantilever configuration increased the shear on Pier 2 of 110 ton and the bending moment of 3000 ton*m circa with respect to the pre-damage (continuous) configuration. The shear increased on both side of Pier 2 since bending increased the reaction on Pier 2 unloading Pier 1 (Addis side) thus increasing shear also on the span from Pier 1 to 2. The above mentioned values do not take into account dynamic effects which may have increased the cantilever stresses (vertical vibrations) or added additional stresses via other dynamic mechanisms (axial impulse/vibration). The sharp increase of bending moment over Pier 2 was later confirmed by a closer inspection of the deck (Fig.5). The beams lower part had a large portion of concrete cover spalled and the reinforcing bars seemingly buckled.

Obviously the damage situation would have deteriorated because of rusting of the reinforcing bars exposed through the macro cracks and concrete cover spalled areas. Apart from a reduction of the net steel area, the resisting mechanisms which are very likely to deteriorate because of rusting and cyclic loading is the bond between rebars and concrete in the vicinity of the macro cracks. Once the cracks widen because of bond deterioration and/or rebar yielding, forces transmitted by aggregate interlock suddenly vanish potentially causing very brittle shear failure with associated collapse of the superstructure. The risk of a similar event in case of heavy loads crossing the bridge was therefore the prime source of concern.

the most effective means to reduce bending and shear forces and introduce compressive ones to seal the macro cracks. The deck depth and the diaphragms provided an optimal configuration for the cables to be deviated using steel saddles fixed to the concrete structure. Six cables with 12 (06”) strands could be easily spun under the deck, two on each side of the internal beams and one each on the inner side of the lateral beams. The reason for not having cables on the outer side (of the lateral beams) is that these cables could not be deviated using the diaphragms and would be more exposed to weathering agents while spoiling the bridge aesthetic.

Before tensioning the cables, the major damages of the concrete deck have been repaired so as to benefit from the application of the prestressing forces. The wider cracks have been injected with epoxy resin, the large spalled portions near the supports and other major honeycombs have been repaired with highly fluid cement mortar. For the larger damaged areas, small diameter reinforcement has been added. The amount and extension of the repair works carried out on the concrete girder has been limited by budget restraint and cost-effectiveness evaluation. The authors have suggested ERA to proceed with a complete overhaul of the deck concrete surface in the near future. Luckily enough, Ethiopia benefits from a dry and warm weather that extends concrete structure service life well beyond European and North American standards.

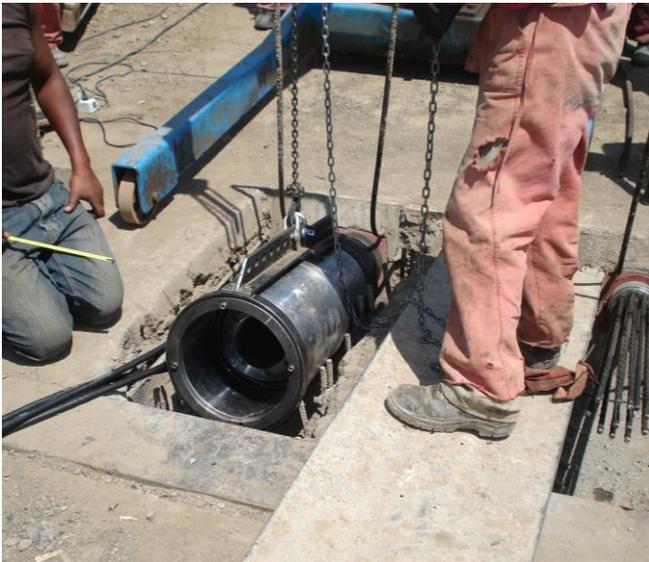
Figure 6 – Anchorage slot in the top slab

The slot of the cable anchorages have been cut into the top slab and the additional reinforcing block cast from below the deck all in the same phase. Vehicles could run over temporary steel plates positioned over the anchorage slots.

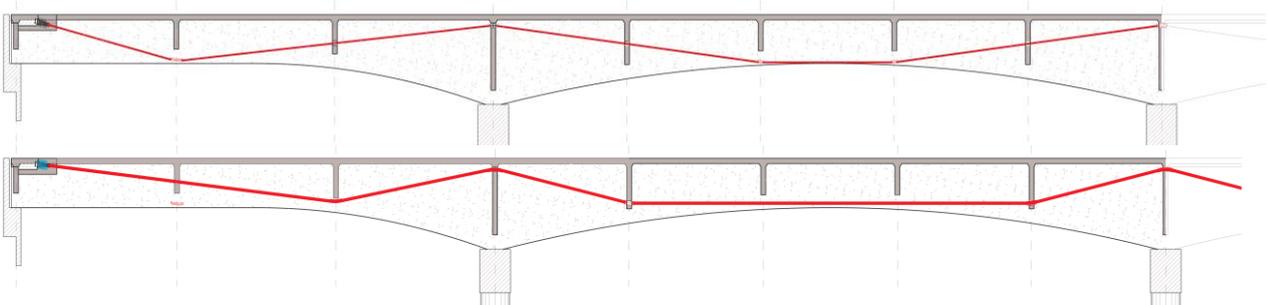
Fig. 7 – Cables Type A (above) and Type B (below)

Longitudinal layout of the cables is optimized to counteract bending and shear due to self weight of the bridge. The cables are continuous over the whole length of the deck (120m circa) and anchored on the deck slab near the abutments. The cables follow two different layouts, one for the 4 inner cables (Type A) and another for the outer ones (Type B).

The two layouts have been chosen so as to introduce the optimal deviation forces at each diaphragm.

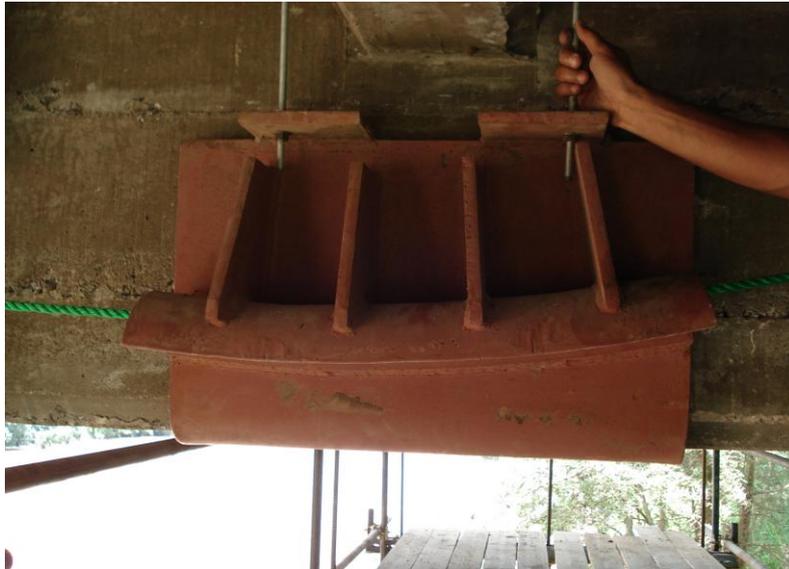
Figure 8 – Deviation saddle

Cables are deviated using steel saddles and steel pipes directly glued onto the existing concrete sections. Only in few cases, at the anchorages and at the deviations of Cable Type B over the piers, additional cast in situ concrete blocks were required to allow for a safe transmission of the cable forces to the existing concrete section. Special care has been taken in the correct positioning of the deviation elements. Previous experiences suggested to check their correct positioning using a nylon rope before the saddles were glued and the strands were spun.

As a matter of fact position and orientation are both very important because forces arising from strands jammed into the deviators can be as high as the tensioning force and therefore much higher

than what the concrete sections can locally sustain. This was certainly the case for the Gibe bridge diaphragms that are insufficiently reinforced and therefore could only take the upward design deviation forces and would not bear any tangential ones. The 6 cables tensioned to 1000 MPa apply a total compression force of 1000 ton. The vertical component at the deviation points varies between 20 to 30 ton (upwards) for the 4 intermediate diaphragm along each span and from 70 to 110 ton (down-wards) at piers and abutment.

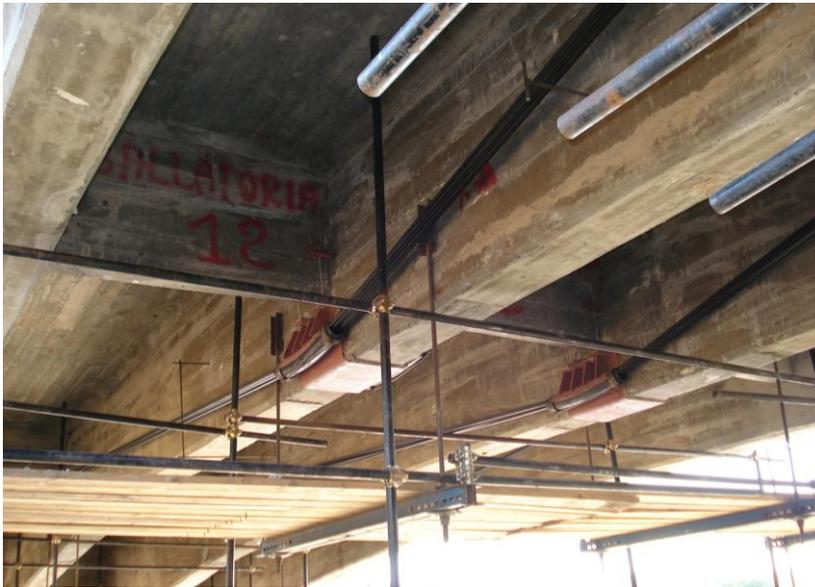
Fig. 9 – Suspended scaffolding at deviation points

The principal advantage of the adopted solution is the extreme simplicity of its implementations. All that is needed is a small by-bridge or otherwise suspended scaffolding that is placed at the deviation points as done for the Gibe bridge. The steel saddles and deviation pipes were manufactured in shop and brought to site fully finished. The design of such pieces was optimized so that could be handled by two persons (max 80 kg). Installing of the saddles only required epoxy

resin and small fasteners to hold them in place before the resin hardened and the prestressing force pushed them against the concrete section. Deviation pipes were installed inside holes previously bored into the diaphragms with man held equipment.

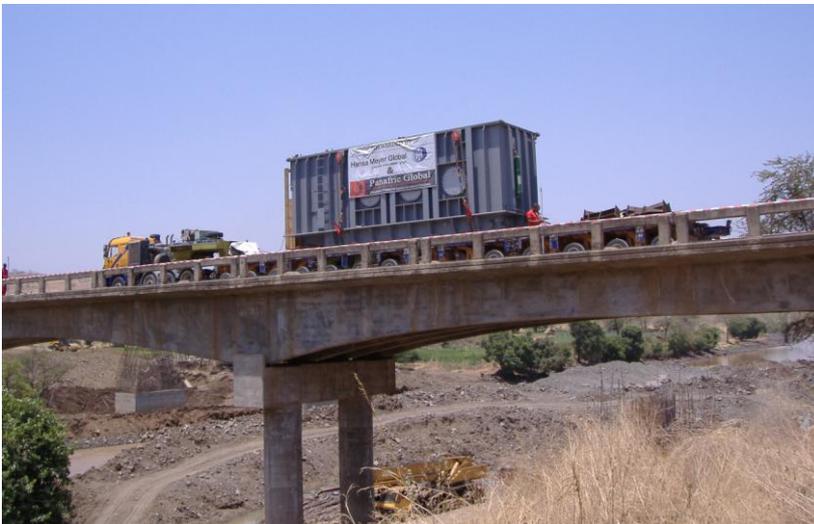
Fig. 10 – The transformer convoy (213 ton) cross the bridge

Few months after the bridge commissioning, Integra has been asked to assess whether the bridge could be crossed by the ultra heavy loads of the Gibe II transformers. Some of these convoys weighted less than 150 ton gross (including the truck) but two of them reached 213 ton gross. Shear forces induced by these heavier convoys would have been very close to the bridge capacity if not exceeding it. Using major international codes such as EC2, the calculated forces using unit load factor for both dead and live load exceeded 90% of the bridge capacity. Taking into account that the bridge did suffer from shear crack at the time of bombing and material properties could not be extensively investigated, the situation was too close to call without further test loads. These new tests

load were conducted so as to simulate the transformer crossing. The bridge was loaded with four 40 tons trucks located so as to maximise shear and hogging moments close to the central piers. The bridge did withstand this test loading although displacements clearly indicated a non linear response due to some sort crack activation or re-activation. Elastic recovery was satisfactory though and therefore crossing of the transformers was given the go ahead.
